# Failure mechanisms of dense vertically-cracked thermal barrier coatings

Manish Madhwal<sup>a</sup>, Eric H. Jordan<sup>b,\*</sup>, Maurice Gell<sup>a</sup>

## Abstract

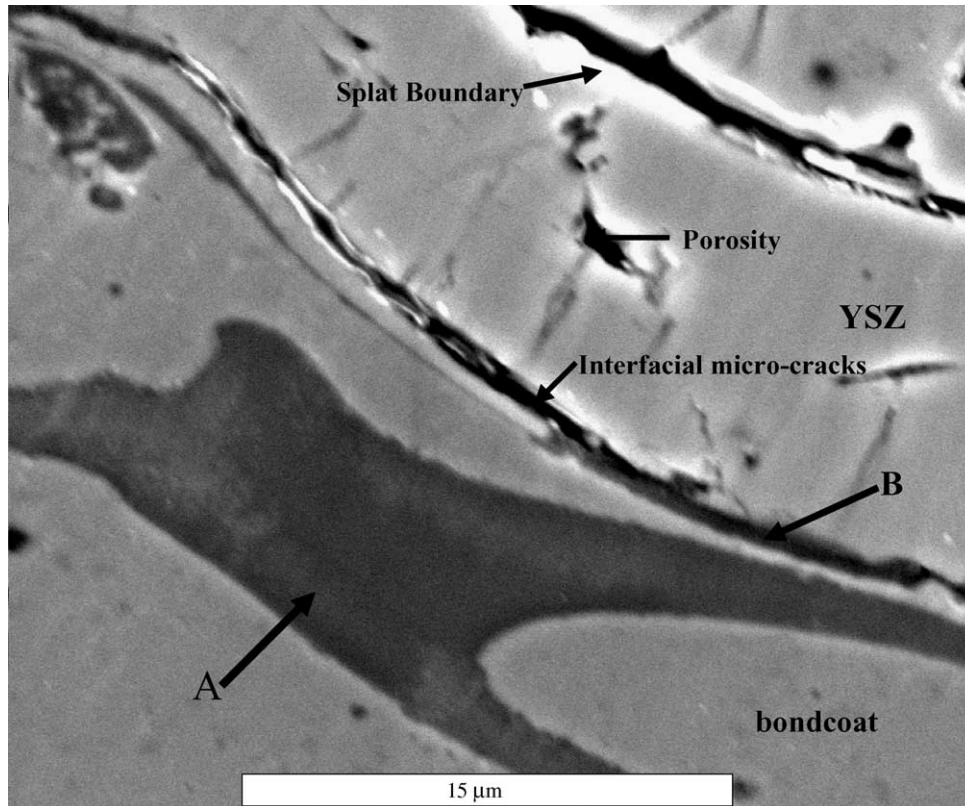
Fig. 3 shows the typical as-received microstructure of the dense vertically-cracked APS TBC near the ceramic–bond coat interface. There are oxides within the bond coat (A) prior to thermal cycling and a thin discontinuous oxide layer along the interface (B). The presence of oxides in the as-received specimen is typical of the APS bond coat. Inter-splat porosities and splat boundaries can also be seen in the ceramic top coat typical to the APS process. The specimens when cycled to failure always fail with the whole ceramic layer spalling as one piece from the substrate (Fig. 4). Once the failure life has been determined, the SEM cross-sections

Fig. 3. Typical as-received DVC TBC cross-section at the interface showing characteristics of the ceramic top coat and bond coat.

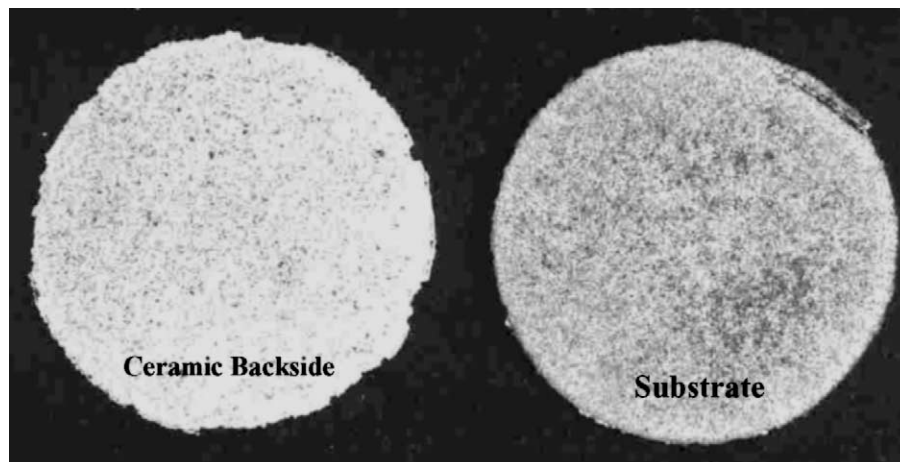
Fig. 4. Macro photographs of the failed sample showing the top view of the spalled substrate and the underside of the spalled ceramic.

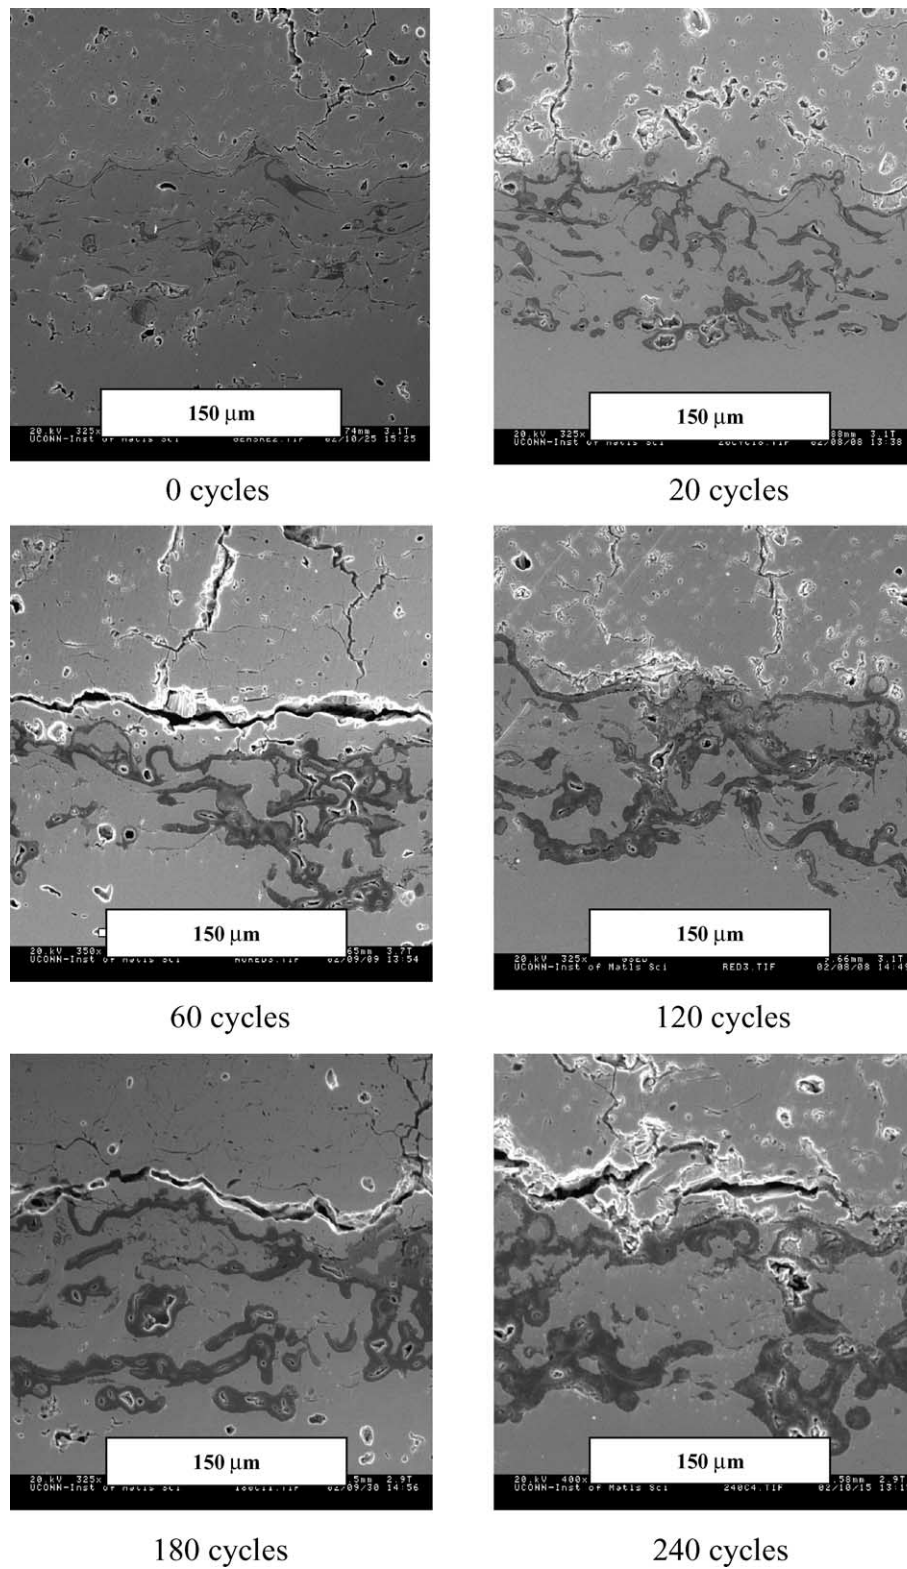
Cracks in the ceramic start appearing as soon as 25% of the failure life with lengths as much as 150–200 μm and maximum crack opening displacements of 10–15 μm. The cracks due to thermal cycling are easily distinguishable from other microcracks in the as-received coating. The crack locations and propagation path are essentially independent of the pre-existing vertical cracks. The association of transverse

Fig. 5. Cross-section SEM micrographs of the samples at various fractions of cyclic life at 1121 °C showing the crack propagation in the ceramic.

The cross-section micrographs of the samples with increasing thermal cycles (Fig. 5) show the propagation of the cracks in the ceramic with cycles. The cracks increase in length with progressive cycles, and their eventual linkage leads to the spallation of the TBC entirely in the ceramic. The crack density of such cracks measured across the entire cross-section of the samples at various fractions of their spallation life is shown in Fig. 6. Crack density is recorded as crack length per unit length of the interface. At any one interface location, there is at most one crack between the interface and the free surface of the TBC. This measure of crack density under the assumption that the section is random corresponds to the area fraction in plan view, lost due to cracking. The crack density was found to vary linearly with thermal cycling. Extrapolation of the crack density to final failure leads to crack densities of  $\approx 0.2$  suggesting that unstable cracking occurs around this damage level. Cross-section micrographs of the failed samples (Fig. 7a) further show that the cracking was entirely in the ceramic, the cross-section of the failed substrate shows that the failure occurred well above the TGO–ceramic interface, thus leaving behind ceramic on the substrate. When the failed ceramic top coat cross-section is studied, we see no remnant TGO attached to the ceramic. However, there are occasional exceptions where the cracks in the ceramic top coat propagate through the TGO into the bond coat asperities and then propagate in the ceramic again (Fig. 7b). The corresponding impressions of such regions can also be found in the ceramic top coat

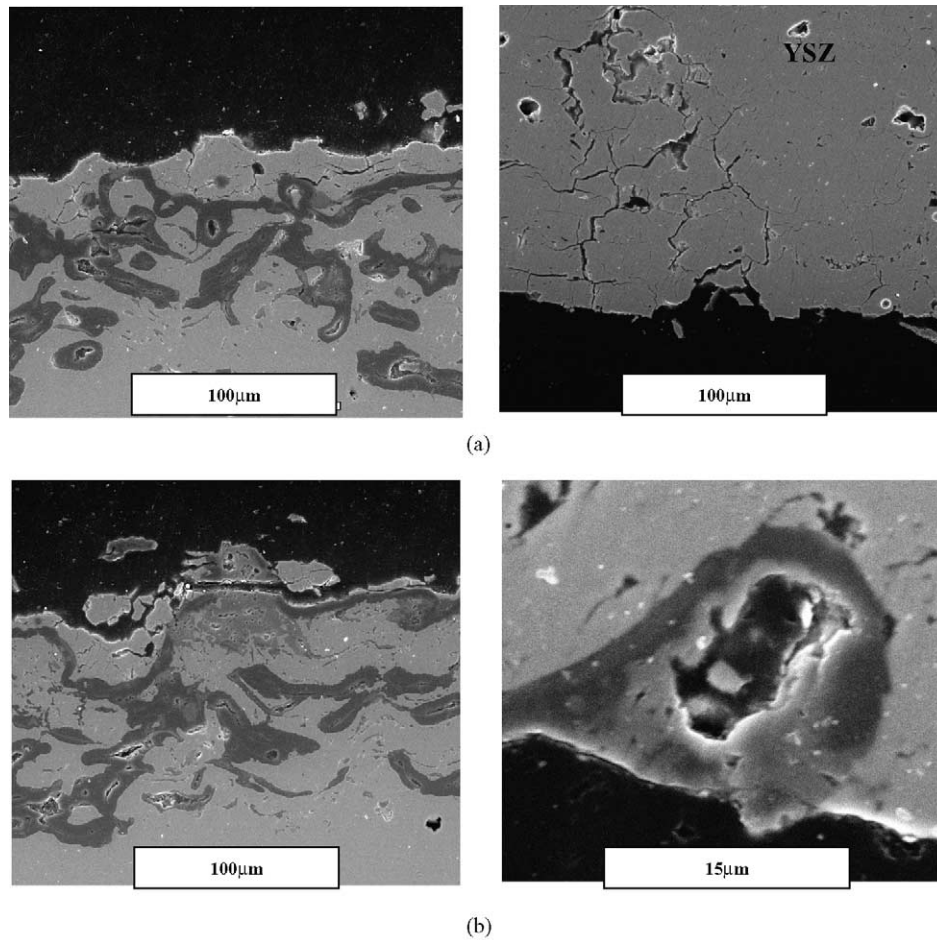
(Fig. 7b) showing the remnant TGO at the bond coat asperities. It was also seen that in all of these exceptional cases, there is a region brighter than the TGO but darker than the bond coat, indicating the presence of oxides of heavier elements of the bond coat. There are no such regions in the initial bond coat cross-section, they develop only later during the cyclic life. Further study of these regions using elemental mapping revealed that these regions are primarily oxides of chromium (Fig. 8). These heavier oxides are closer to the TGO–bond coat interface in the bond coat. The presence of chromia well within the bond coat is rare and occurs only around porosities in the bond coat. The origin and propagation of cracking in the ceramic top coat was similar for the three temperatures.

Fig. 7. Failed cross-sections of the TBC: (a) substrate and corresponding ceramic top coat entire crack growth is in ceramic; (b) substrate and corresponding ceramic top coat with cracking through the bond coat.

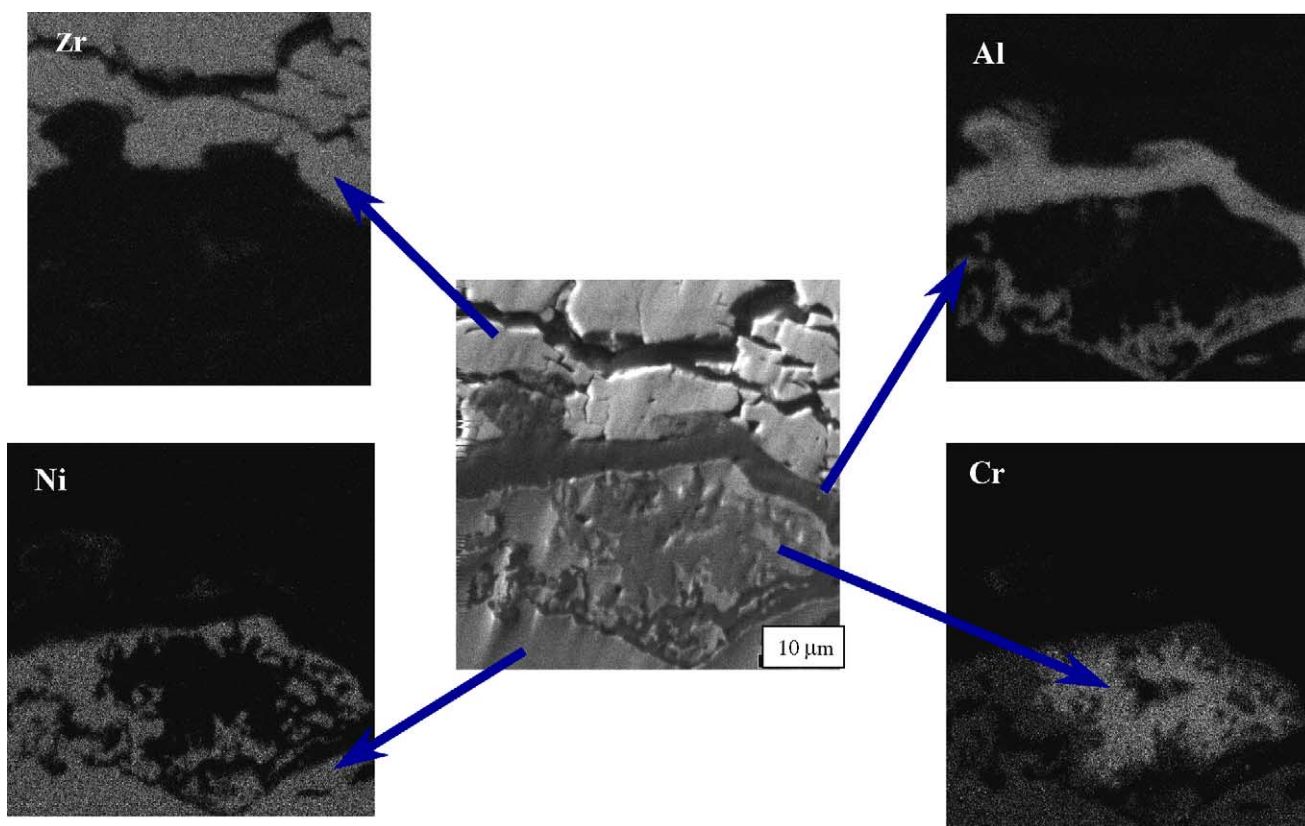
Fig. 8. Elemental maps using EDAX showing the presence of chromium oxides within the bond coat.

in the bond coat form. The rate of Al depletion is higher at higher temperatures due to higher reaction rates. Chromia, confirmed by EDAX, appears only in the late stages of thermal cycling, when the aluminum content of the bond coat is severely depleted.

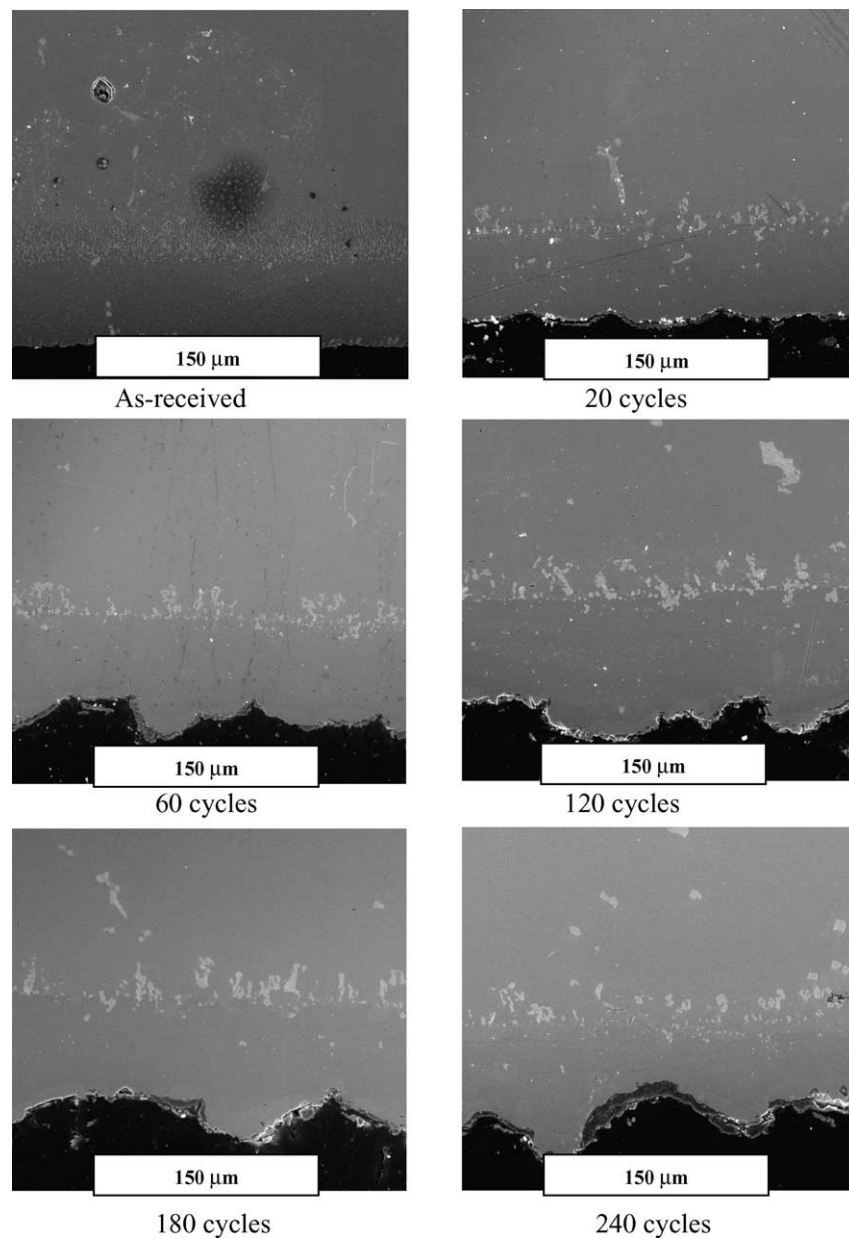
Image analysis was used to calculate the average roughness ( $R_a$ ) of the ceramic–bond coat interface. A sampling length of 15 mm was used for each sample. The extent of rumpling was fairly extensive on the unconstrained bottom surface of the bond coat (Fig. 11), indicating that this particular NiCrAlY bond coat had a tendency to rumple with thermal cycling. However, mechanical constraint of TBC, especially for the dense low-stress TBC as in the present case, will reduce the rumpling rate. Average roughness ( $R_a$ ) of the bond coat to ceramic top coat interface increased from 17 µm in the as-received condition to 24 µm at 80% of the life fraction for 1121 °C (Fig. 12). The average roughness at 80% life fraction for the samples tested at 1100 °C also increased from 17 µm to 25 µm. The DVC TBC specimen tested at 1151 °C at 75% of its life fraction showed an increased roughness to  $\approx 27$  µm. The average roughness values close to failure in the DVC TBC specimen for all three

Fig. 11. Cross-section SEM micrographs of the bare bond coated side showing progressive distortion of the bond coat with thermal cycling.
