Failure mechanisms of dense vertically-cracked thermal barrier coatings

Manish Madhwal^a, Eric H. Jordan^{b,*}, Maurice Gell^a

Abstract

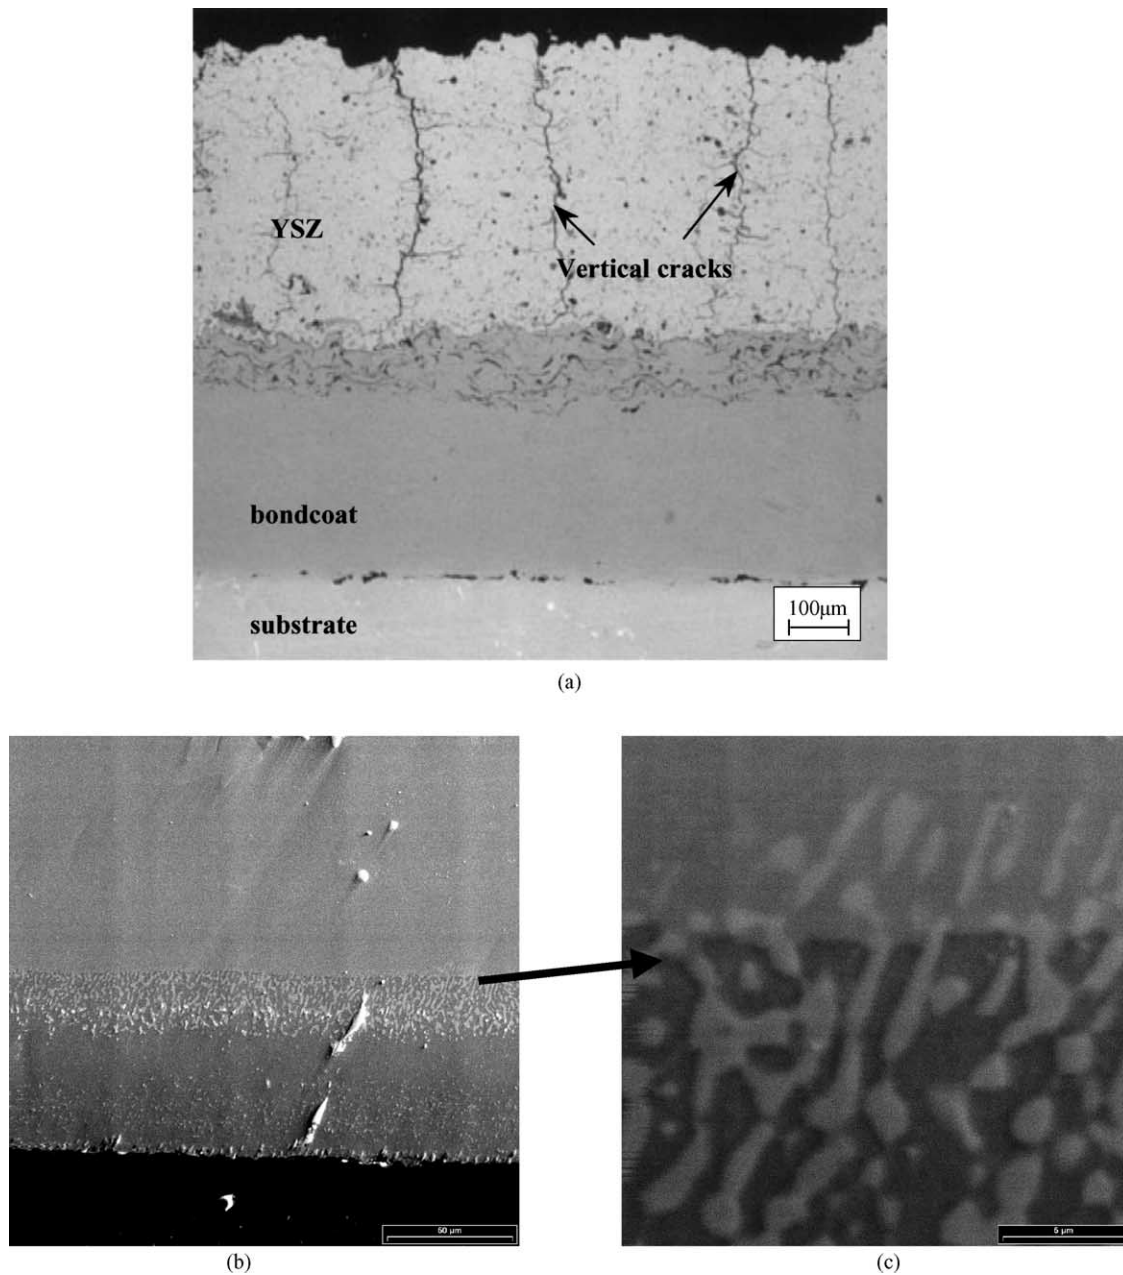
Plasma-sprayed coatings are prone to large scale spallation as the cracks induced due to thermal stresses propagate to failure. Vertical microcracks (see Fig. 1) are deliberately introduced in the ceramic top coat of the coating test in the present case to relieve thermal mismatch stresses, thus reducing tendency of the ceramic to crack and buckle [9]. In the plasma spray process, the molten YSZ particle forms splats on impacting the substrate surface, the coating is deposited layer by layer on the substrate and superimposing the splats within each layer. Each layer upon solidification forms vertical cracks due to shrinkage. The cracks in adjacent layers connect to form through coating thickness cracks.

Fig. 1. (a) Cross-sectional SEM micrograph showing various layers in the TBC, (b) cross-sectional micrograph of the specimen bottom surface and (c) magnified image of the two-phase region of the NiCrAlY bond coat.

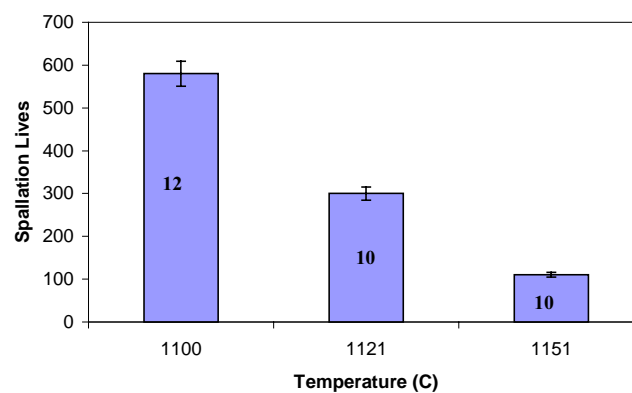
The average failure lives at 1100 °C, 1121 °C and 1151 °C are given in Fig. 2. The average spallation life is nearly halved when the cycling temperature is increased from 1100 °C to 1121 °C. A difference of 51 °C in the temperature at the hot time resulted in six times decrease in the failure life. The samples showed consistent spallation lives with small scatter at a particular temperature. However, the spallation lives showed a strong dependence on temperature. Contrary to reported service experience, the failure lives of these DVC TBCs are somewhat lower than those of good APS coatings tested in the same furnace. It will be shown that the rate of bond coat oxidation and rumpling may account for these surprising results.

Fig. 2. Total cycles to failure for 1100 °C, 1121 °C and 1151 °C for DVC TBC system. The number on the bar represents number of samples tested.

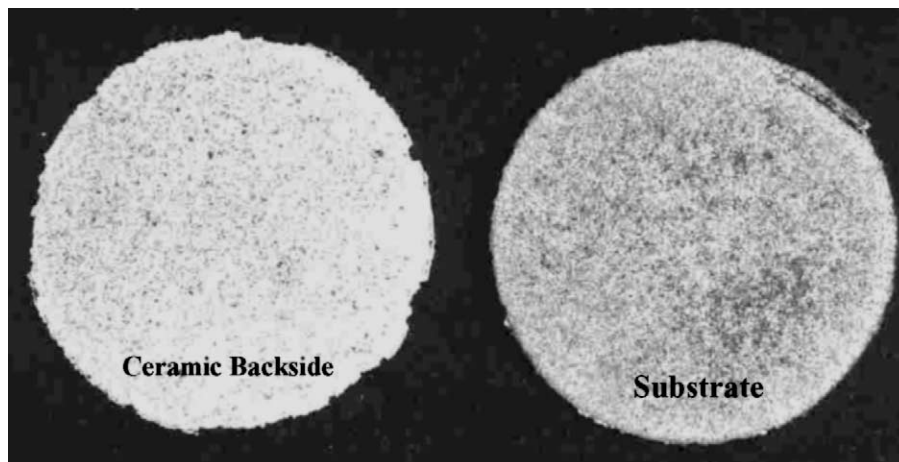
Fig. 4. Macro photographs of the failed sample showing the top view of the spalled substrate and the underside of the spalled ceramic.

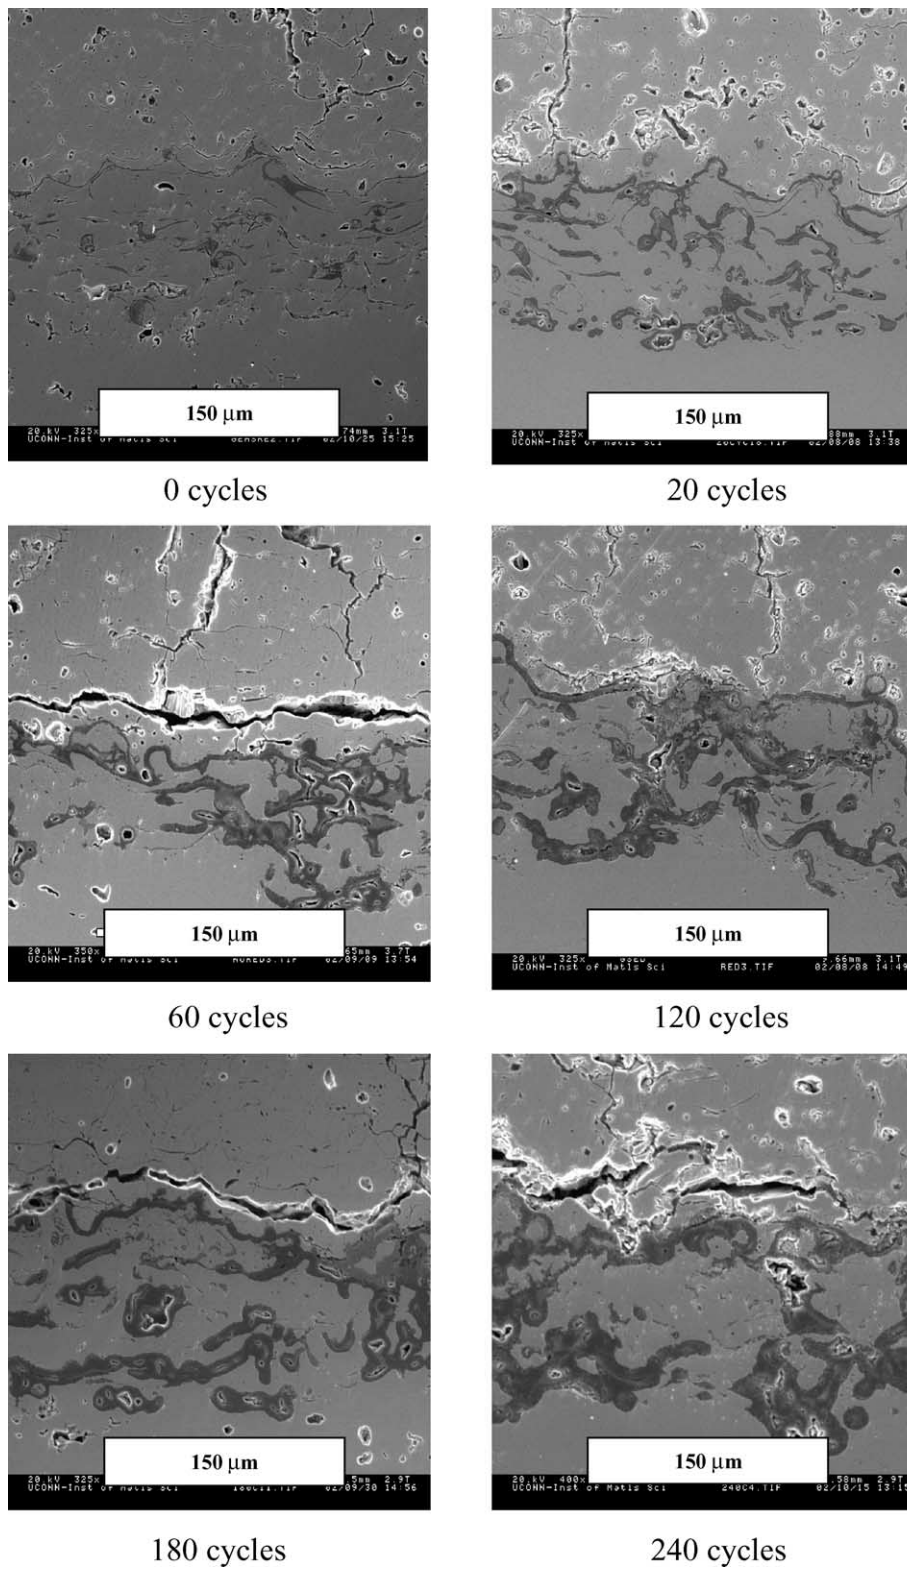
at different life fractions reveal further details concerning the crack initiation, propagation and linkage in this coating (Fig. 5). The discontinuous oxide layer in the as-received cross-sections becomes uniform and starts growing with increasing cycles. The oxides in the bond coat seen in the as-received cross-section grow progressively due to considerable oxidation of the bond coat. These oxides within the bond coat are a result of pores connected to interfaces that provide pathway for oxygen ingress [10]. No obvious signs

Cracks in the ceramic start appearing as soon as 25% of the failure life with lengths as much as 150–200 μm and maximum crack opening displacements of 10–15 μm. The cracks due to thermal cycling are easily distinguishable from other microcracks in the as-received coating. The crack locations and propagation path are essentially independent of the pre-existing vertical cracks. The association of transverse

Fig. 5. Cross-section SEM micrographs of the samples at various fractions of cyclic life at 1121 °C showing the crack propagation in the ceramic.

The cross-section micrographs of the samples with increasing thermal cycles (Fig. 5) show the propagation of the cracks in the ceramic with cycles. The cracks increase in length with progressive cycles, and their eventual linkage leads to the spallation of the TBC entirely in the ceramic. The crack density of such cracks measured across the entire cross-section of the samples at various fractions of their spallation life is shown in Fig. 6. Crack density is recorded as crack length per unit length of the interface. At any one interface location, there is at most one crack between the interface and the free surface of the TBC. This measure of crack density under the assumption that the section is random corresponds to the area fraction in plan view, lost due to cracking. The crack density was found to vary linearly with thermal cycling. Extrapolation of the crack density to final failure leads to crack densities of ≈ 0.2 suggesting that unstable cracking occurs around this damage level. Cross-section micrographs of the failed samples (Fig. 7a) further show that the cracking was entirely in the ceramic, the cross-section of the failed substrate shows that the failure occurred well above the TGO–ceramic interface, thus leaving behind ceramic on the substrate. When the failed ceramic top coat cross-section is studied, we see no remnant TGO attached to the ceramic. However, there are occasional exceptions where the cracks in the ceramic top coat propagate through the TGO into the bond coat asperities and then propagate in the ceramic again (Fig. 7b). The corresponding impressions of such regions can also be found in the ceramic top coat

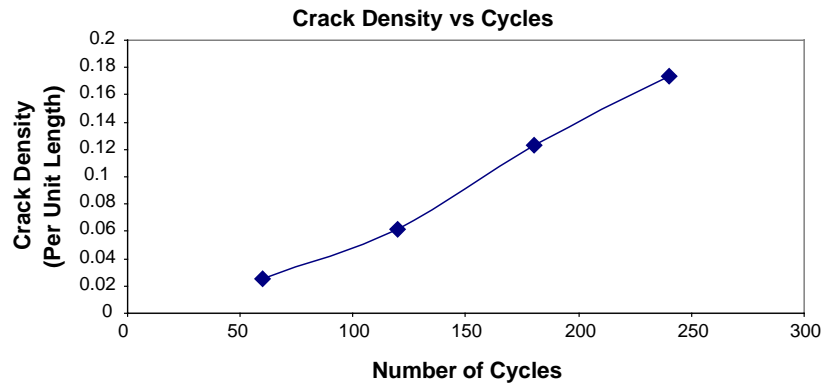
Fig. 6. Crack density measured across the entire specimen cross-section plotted against number of thermal cycles (1121 °C).

The proposed explanation is consistent with the four observations of the present study. First, the severity of rumpling at failure was approximately constant across specimens tested at different temperatures, with the average bond coat roughness (R_a) increasing from an initial value of $\approx 17 \mu\text{m}$ to $\approx 25 \mu\text{m}$ at failure. Thus, life reduction with increased temperature was produced by the increased rumpling rate with temperature. Second, the cracking was progressive and (Fig. 6) paralleled the development of bond coat roughness,

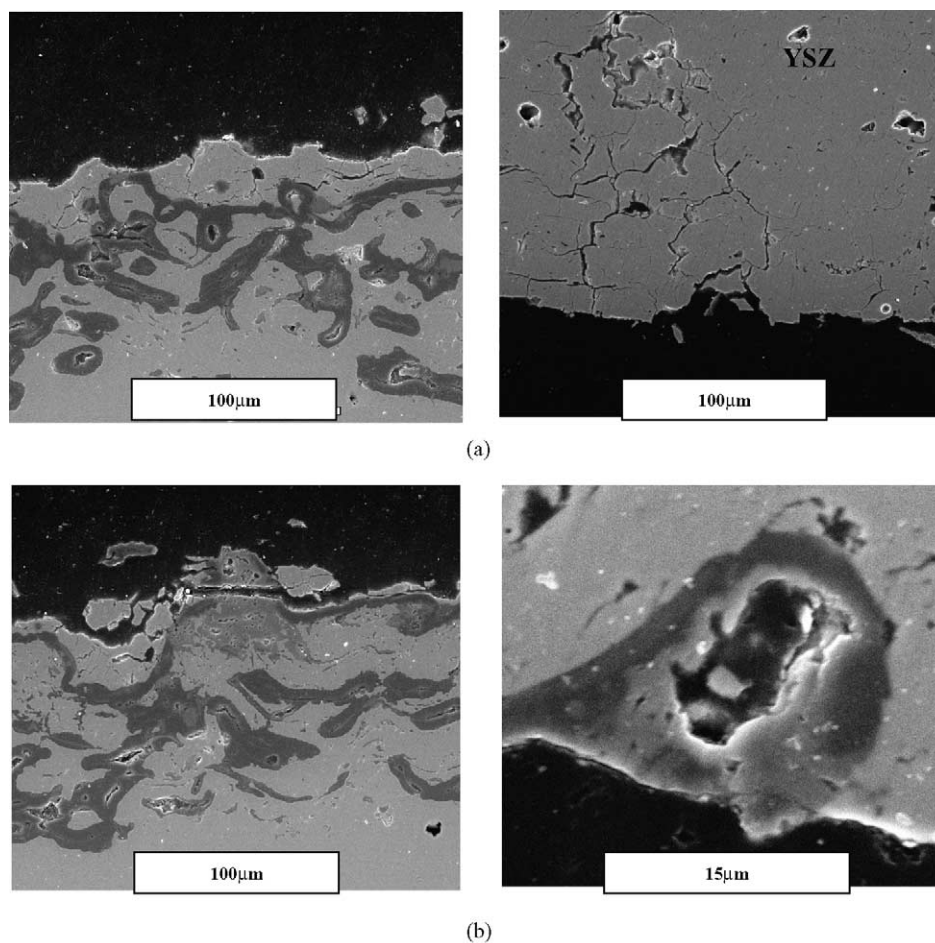
(Fig. 7b) showing the remnant TGO at the bond coat asperities. It was also seen that in all of these exceptional cases, there is a region brighter than the TGO but darker than the bond coat, indicating the presence of oxides of heavier elements of the bond coat. There are no such regions in the initial bond coat cross-section, they develop only later during the cyclic life. Further study of these regions using elemental mapping revealed that these regions are primarily oxides of chromium (Fig. 8). These heavier oxides are closer to the TGO–bond coat interface in the bond coat. The presence of chromia well within the bond coat is rare and occurs only around porosities in the bond coat. The origin and propagation of cracking in the ceramic top coat was similar for the three temperatures.

Fig. 7. Failed cross-sections of the TBC: (a) substrate and corresponding ceramic top coat entire crack growth is in ceramic; (b) substrate and corresponding ceramic top coat with cracking through the bond coat.

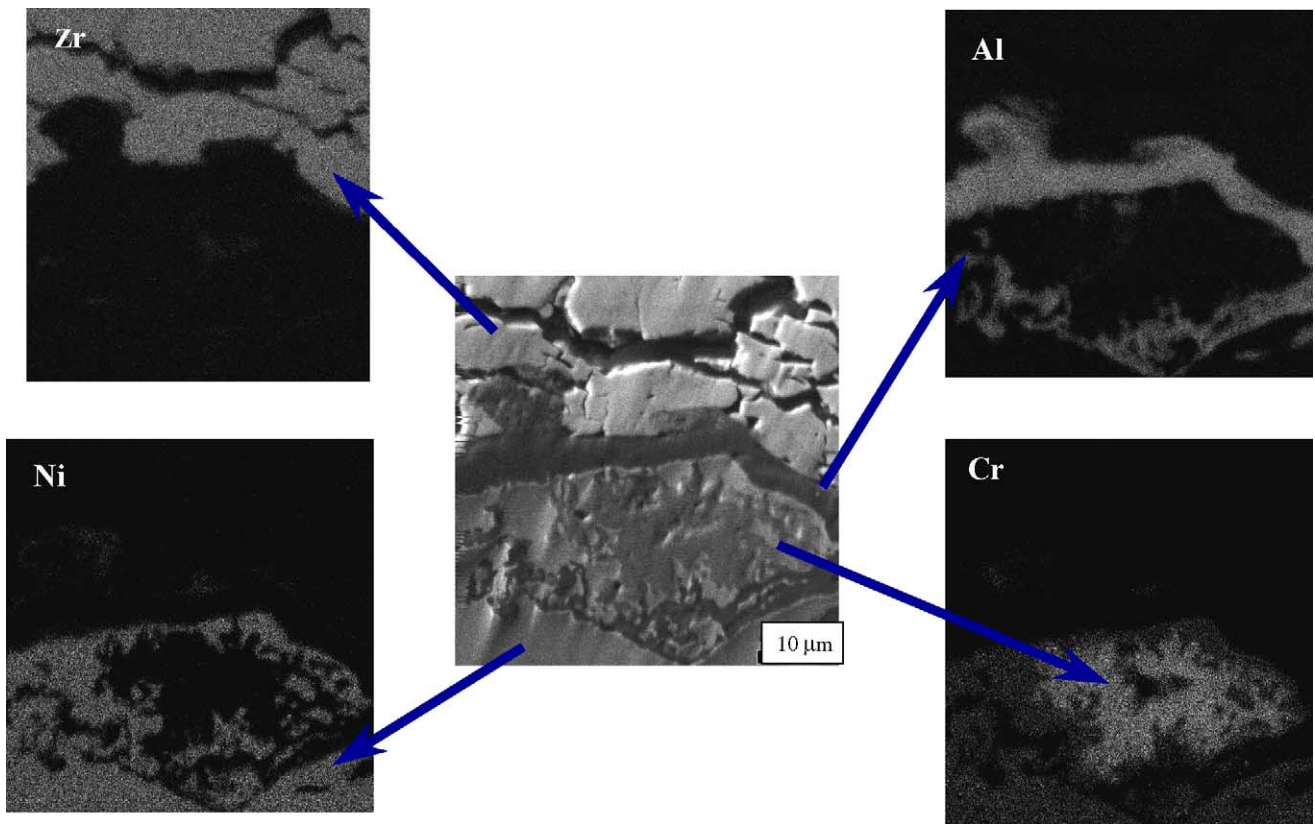
Fig. 8. Elemental maps using EDAX showing the presence of chromium oxides within the bond coat.

in the bond coat form. The rate of Al depletion is higher at higher temperatures due to higher reaction rates. Chromia, confirmed by EDAX, appears only in the late stages of thermal cycling, when the aluminum content of the bond coat is severely depleted.

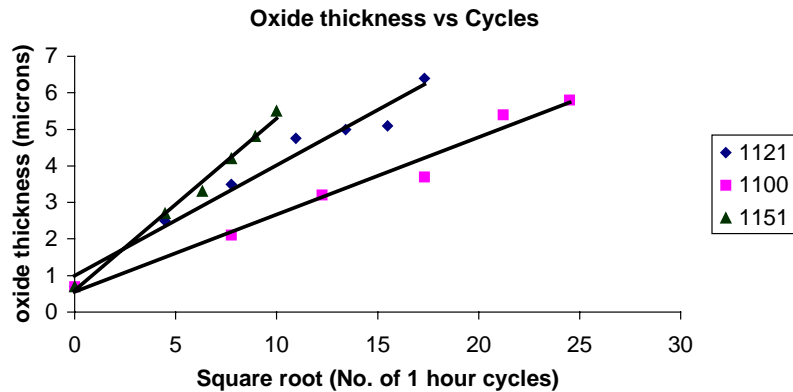
TGO thickness measured at various fractions of the total spallation life for the three temperatures, when plotted against the square root of the number of 1-h cycles, results in an almost linear trend (Fig. 9). This indicates that the oxide growth follows the parabolic rate law typical of continuous scales, given by:

where h is the thickness, t is the time and k_p is the parabolic rate constant. The slope of the linear trend lines in Fig. 9 is proportional to the square root of the parabolic rate constant at the specified temperature. The values thus obtained for the parabolic rate constants from the experimental results are $1.6 \times 10^{-17} \text{ m}^2/\text{s}$ at 1100 °C, $2.5 \times 10^{-17} \text{ m}^2/\text{s}$ at 1121 °C and $6.4 \times 10^{-17} \text{ m}^2/\text{s}$ at 1151 °C. These values agree very well with parabolic rate constants for alumina formers in literature [5,11,13]. Due to the presence of TGO ($\approx 0.7 \mu\text{m}$ thick) in the as-received samples (prior to thermal cycling), the experimental results do not strictly follow Eq. (1), and the curves in Fig. 9 do not intersect the origin. However, the parabolic rate constant values are obtained from the slope of the lines, and the presence of initial TGO does not result in large errors. The study of three different temperatures also enables us to comment on the activation energy of α -alumina

Fig. 9. Oxide thickness (μm) plotted against square root of number of cycles for three different temperatures.

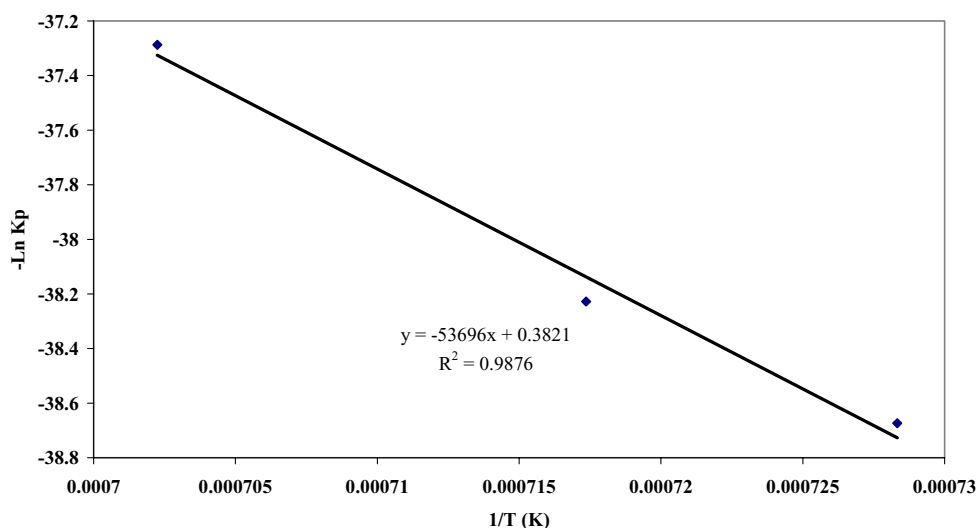
From the curves for the oxide growth at the three temperatures (Fig. 10), we can confirm that these relationships are closely followed in the oxidation behavior. The slopes of the trend lines are proportional to the square roots of the parabolic rate constants at a particular temperature, the increasing slopes with temperature in the experimental results conform to the trend expected based on Eq. (3). A plot of natural log of parabolic rate constant against reciprocal of the absolute temperature is shown in Fig. 10. The activation energy for α -alumina growth obtained from Fig. 10 was found to be 446 kJ/mole. Experimentally calculated values for activation energy of oxygen grain boundary diffusion in polycrystalline alumina are 460 ± 60 kJ/mole [14,15], the value of activation energy obtained here is consistent with grain boundary diffusion as the rate-controlling step in TGO growth. Oxide thickness at failure at all the temperatures lies within a very narrow range of 5–6 μm , indicating that

Fig. 10. Negative of the natural log of parabolic rate constants at three different temperatures vs. $1/T$ (K).

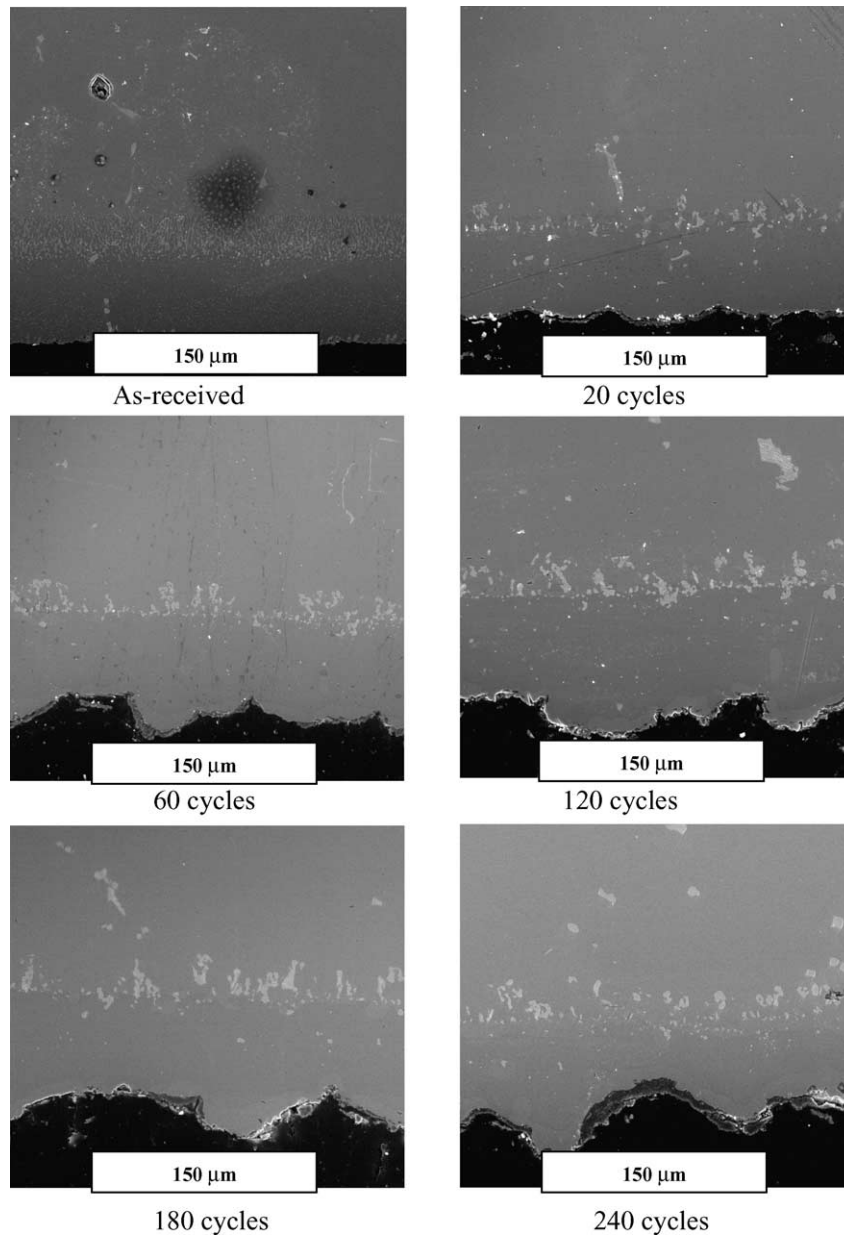
Image analysis was used to calculate the average roughness (R_a) of the ceramic–bond coat interface. A sampling length of 15 mm was used for each sample. The extent of rumpling was fairly extensive on the unconstrained bottom surface of the bond coat (Fig. 11), indicating that this particular NiCrAlY bond coat had a tendency to rumple with thermal cycling. However, mechanical constraint of TBC, especially for the dense low-stress TBC as in the present case, will reduce the rumpling rate. Average roughness (R_a) of the bond coat to ceramic top coat interface increased from 17 μm in the as-received condition to 24 μm at 80% of the life fraction for 1121 °C (Fig. 12). The average roughness at 80% life fraction for the samples tested at 1100 °C also increased from 17 μm to 25 μm . The DVC TBC specimen tested at 1151 °C at 75% of its life fraction showed an increased roughness to ≈ 27 μm . The average roughness values close to failure in the DVC TBC specimen for all three

Fig. 11. Cross-section SEM micrographs of the bare bond coated side showing progressive distortion of the bond coat with thermal cycling.

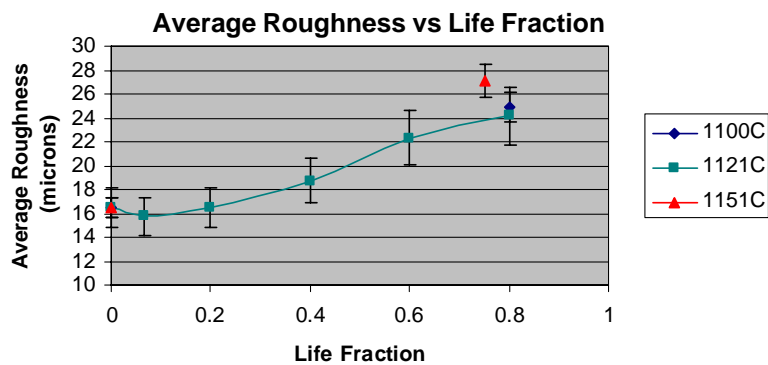
due to rumpling, with thermal cycling (Fig. 12). Third, the failure was exclusively within the ceramic (Figs. 5 and 7). Fourth, the most common alternate failure mechanism, in which the strain energy in the thermally grown oxide generates failure often initiating at bond coat asperities, did not occur. In the DVC TBCs tested, the crack nucleation and propagation occurred in the ceramic, away from the ceramic–TGO interface, thus the high strain energy in the oxide plays no role in the spallation. For this proposed mechanism, suppression of rumpling would increase coating spallation life. Attempts to reduce rumpling in MCrAlY bond coats have been made in the past in order to increase the coating life by changing the bond coat chemistry [31] and the initial bond coat roughness [23].

Fig. 12. Average roughness (R_a) vs. life fraction of the bond coat for the TBC coated side at 1100 °C, 1121 °C and 1151 °C.
