# Failure mechanisms of dense vertically-cracked thermal barrier coatings

Manish Madhwal<sup>a</sup>, Eric H. Jordan<sup>b,\*</sup>, Maurice Gell<sup>a</sup>

## Abstract

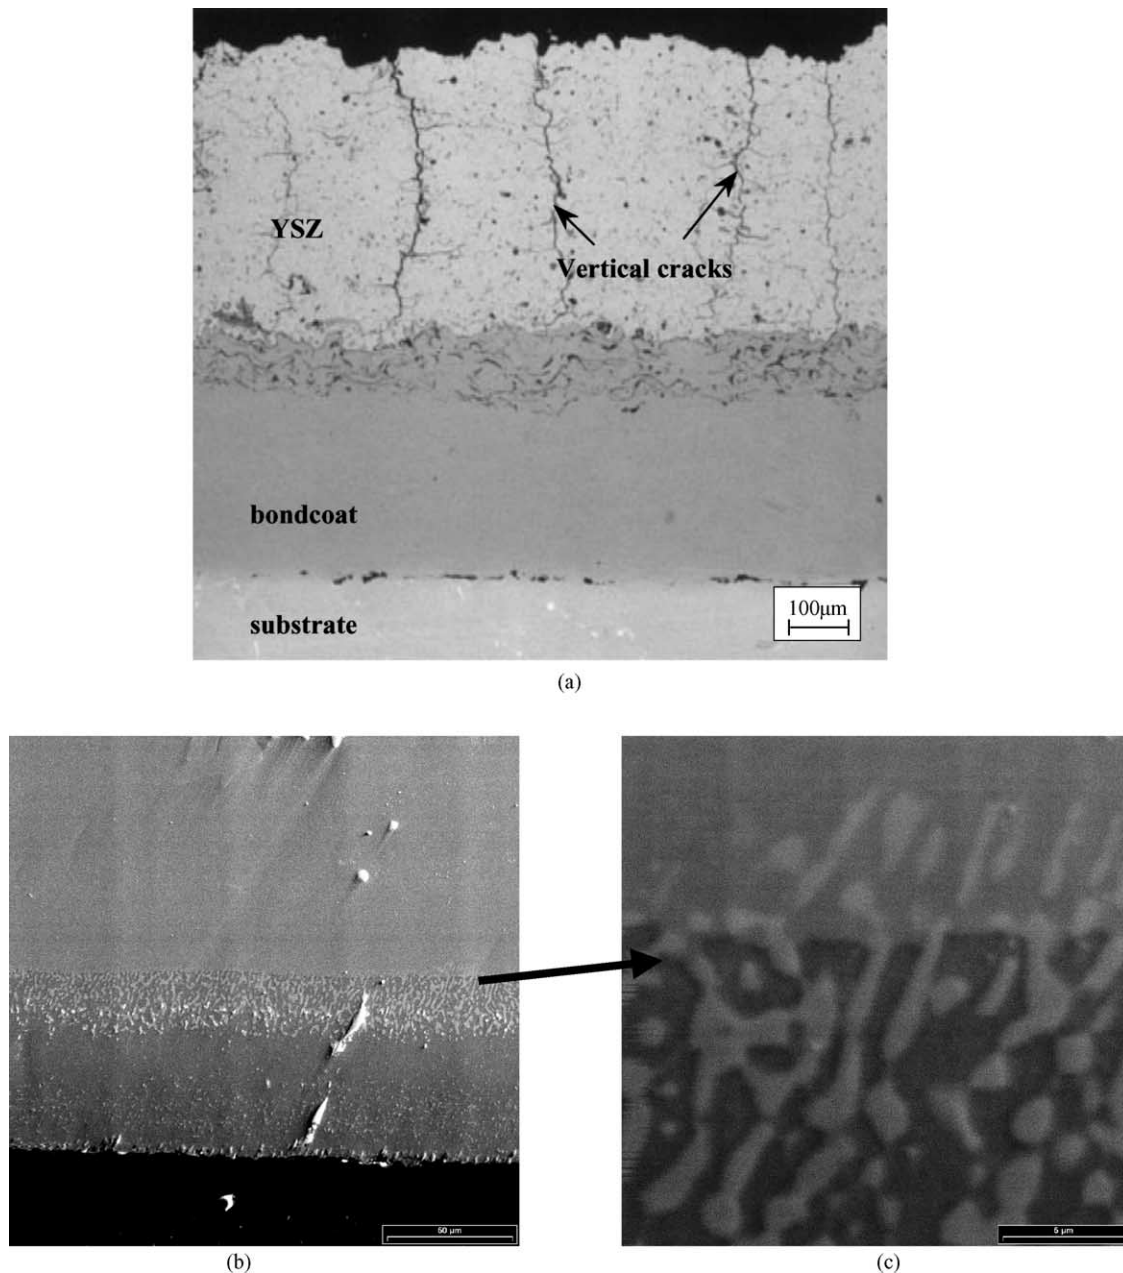
Fig. 1. (a) Cross-sectional SEM micrograph showing various layers in the TBC, (b) cross-sectional micrograph of the specimen bottom surface and (c) magnified image of the two-phase region of the NiCrAlY bond coat.

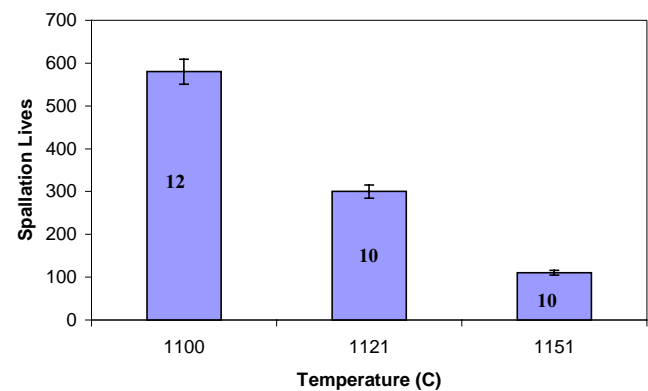
The average failure lives at 1100 °C, 1121 °C and 1151 °C are given in Fig. 2. The average spallation life is nearly halved when the cycling temperature is increased from 1100 °C to 1121 °C. A difference of 51 °C in the temperature at the hot time resulted in six times decrease in the failure life. The samples showed consistent spallation lives with small scatter at a particular temperature. However, the spallation lives showed a strong dependence on temperature. Contrary to reported service experience, the failure lives of these DVC TBCs are somewhat lower than those of good APS coatings tested in the same furnace. It will be shown that the rate of bond coat oxidation and rumpling may account for these surprising results.

Fig. 2. Total cycles to failure for 1100 °C, 1121 °C and 1151 °C for DVC TBC system. The number on the bar represents number of samples tested.

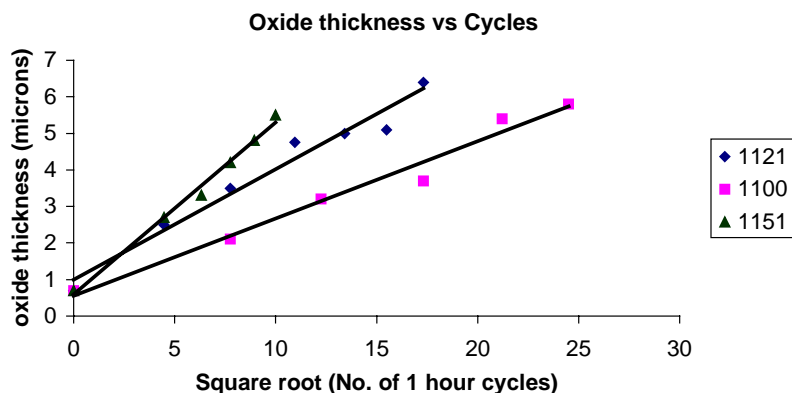
TGO thickness measured at various fractions of the total spallation life for the three temperatures, when plotted against the square root of the number of 1-h cycles, results in an almost linear trend (Fig. 9). This indicates that the oxide growth follows the parabolic rate law typical of continuous scales, given by:

where  $h$  is the thickness,  $t$  is the time and  $k_p$  is the parabolic rate constant. The slope of the linear trend lines in Fig. 9 is proportional to the square root of the parabolic rate constant at the specified temperature. The values thus obtained for the parabolic rate constants from the experimental results are  $1.6 \times 10^{-17} \text{ m}^2/\text{s}$  at 1100 °C,  $2.5 \times 10^{-17} \text{ m}^2/\text{s}$  at 1121 °C and  $6.4 \times 10^{-17} \text{ m}^2/\text{s}$  at 1151 °C. These values agree very well with parabolic rate constants for alumina formers in literature [5,11,13]. Due to the presence of TGO ( $\approx 0.7 \mu\text{m}$  thick) in the as-received samples (prior to thermal cycling), the experimental results do not strictly follow Eq. (1), and the curves in Fig. 9 do not intersect the origin. However, the parabolic rate constant values are obtained from the slope of the lines, and the presence of initial TGO does not result in large errors. The study of three different temperatures also enables us to comment on the activation energy of  $\alpha$ -alumina

Fig. 9. Oxide thickness ( $\mu\text{m}$ ) plotted against square root of number of cycles for three different temperatures.

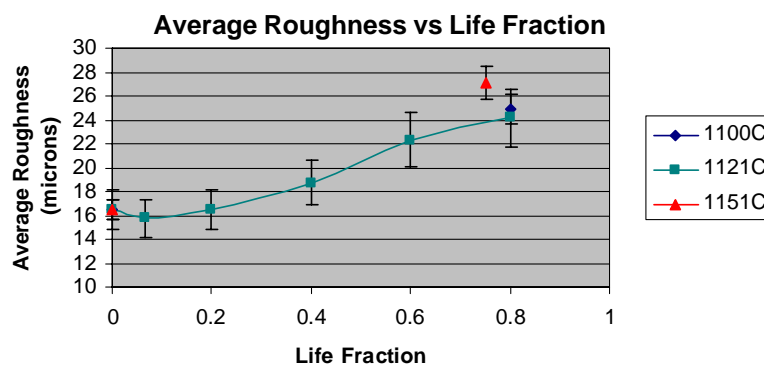
due to rumpling, with thermal cycling (Fig. 12). Third, the failure was exclusively within the ceramic (Figs. 5 and 7). Fourth, the most common alternate failure mechanism, in which the strain energy in the thermally grown oxide generates failure often initiating at bond coat asperities, did not occur. In the DVC TBCs tested, the crack nucleation and propagation occurred in the ceramic, away from the ceramic–TGO interface, thus the high strain energy in the oxide plays no role in the spallation. For this proposed mechanism, suppression of rumpling would increase coating spallation life. Attempts to reduce rumpling in MCrAlY bond coats have been made in the past in order to increase the coating life by changing the bond coat chemistry [31] and the initial bond coat roughness [23].

Fig. 12. Average roughness ( $R_a$ ) vs. life fraction of the bond coat for the TBC coated side at 1100 °C, 1121 °C and 1151 °C.
